# Sidewalk Inventory and Analysis Executive Summary Texarkana MPO

Prepared by:  
Data Transfer Solutions, LLC  
3680 Avalon Park East Blvd., Suite 200  
Orlando, FL 32828  
[www.dtsgis.com](http://www.dtsgis.com)

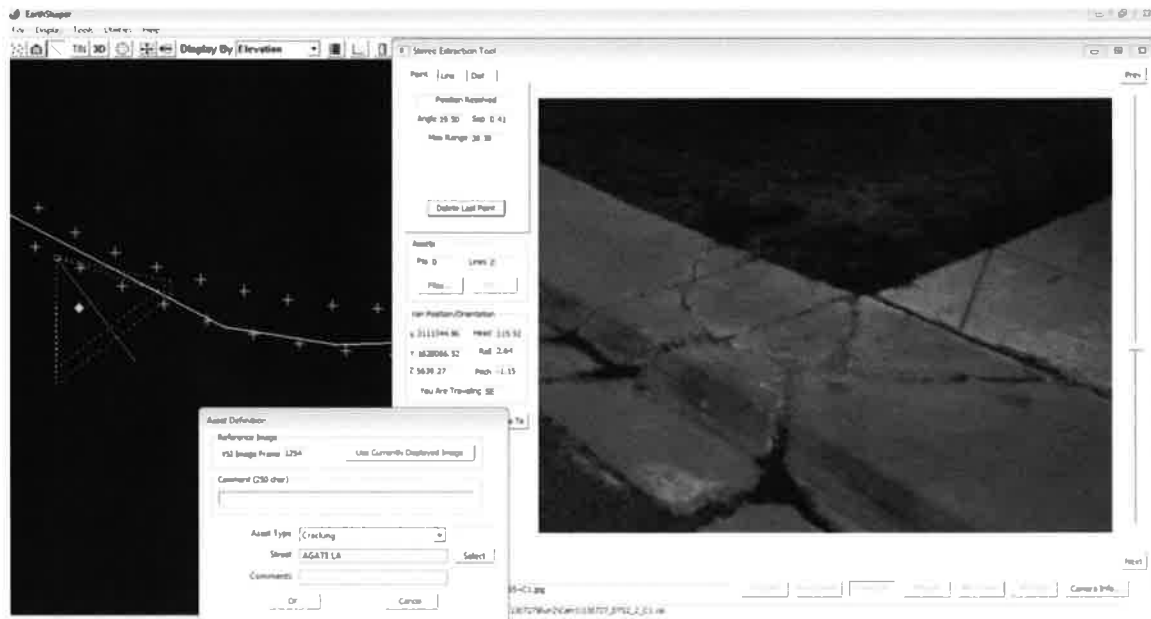
**Figure 8 – Sidewalk Cracking Verified in EarthShaper™**

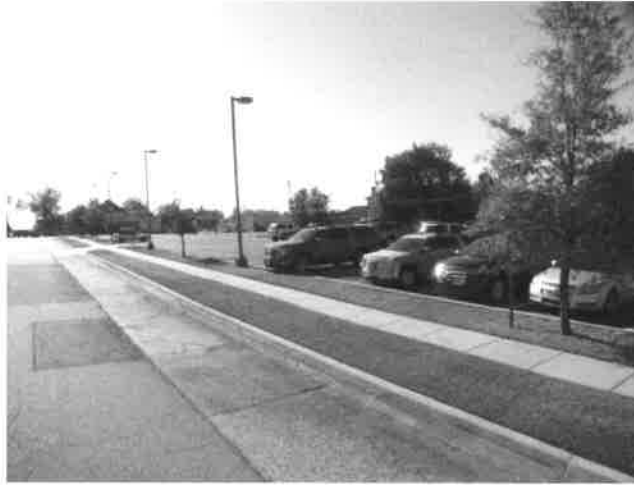
**Figure 20 – Example Imagery of Sidewalk Condition (Good)**

The sidewalk observed in the image above is level, contains minimal to no joint seal damage, and no dividing cracks in the individual concrete slabs. Assessment places this sidewalk segment firmly within the 'GOOD' condition rating

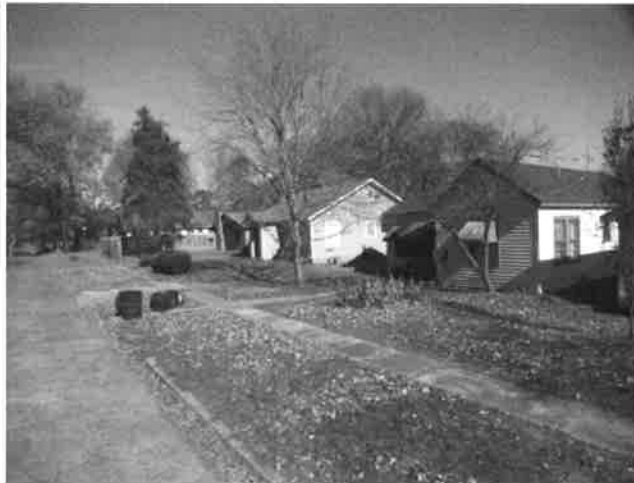
**Figure 21 – Example Imagery of Sidewalk Condition (Fair)**

The sidewalk observed in the image above is mostly level, but contains moderate joint seal damage in the form of invasive grass growth. The individual slabs also display low severity weathering and sporadic chipping. Assessment places this sidewalk segment within the 'FAIR' condition rating.

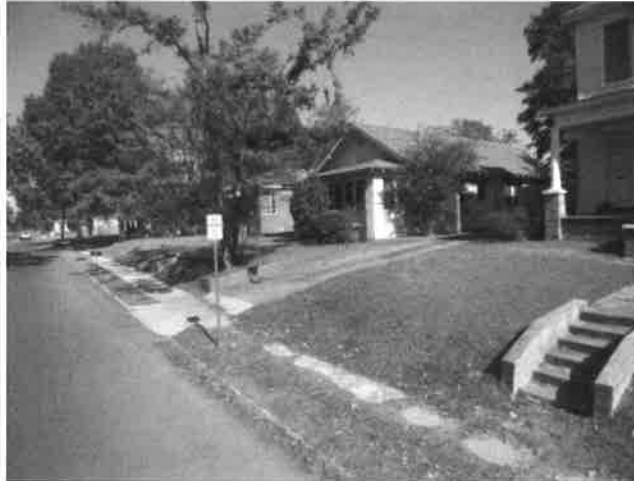
**Figure 22 – Example Imagery of Sidewalk Condition (Poor)**

The sidewalk observed in the image above is not level, and a portion of the segment has been destroyed by extremely invasive grass growth. Individual sidewalk slabs also display severe weathering and moderate chipping. Assessment places this sidewalk segment firmly within the 'POOR' condition rating.
